**Arboricultural Report:**  
**Select lime trees at The Croft, Rolleston-on-Dove**

**Prepared for:**  
Rolleston-on-Dove Parish Council  
c/o Clerk Mary Danby BA (Hons)  
32 Hillcroft Rise  
Burntwood  
Staffordshire  
WS7 6SH

Document reference: 1053/26, Revision 0

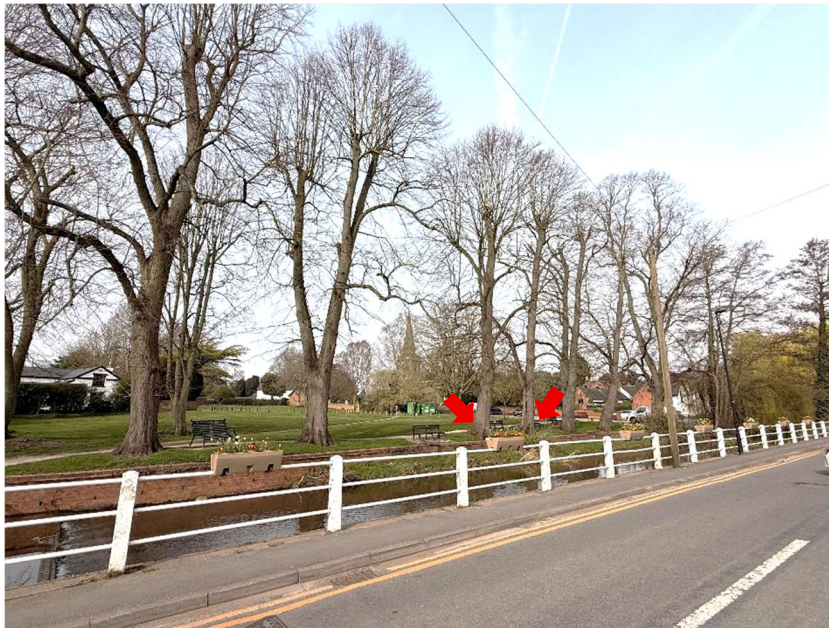
Photograph 1: Showing the row of boundary lime trees with the report trees being indicated by red arrows.

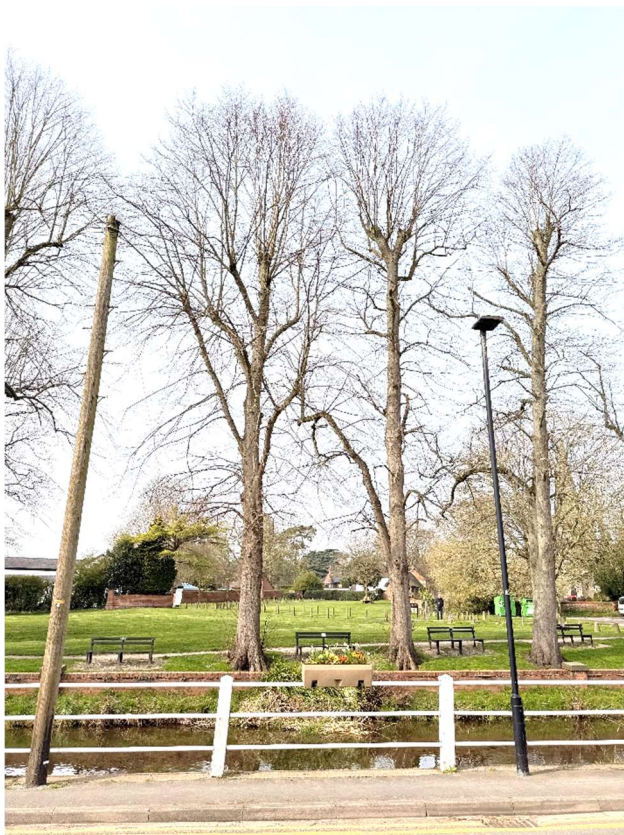
Photograph 2: Looking towards the two report lime trees from the roadside.

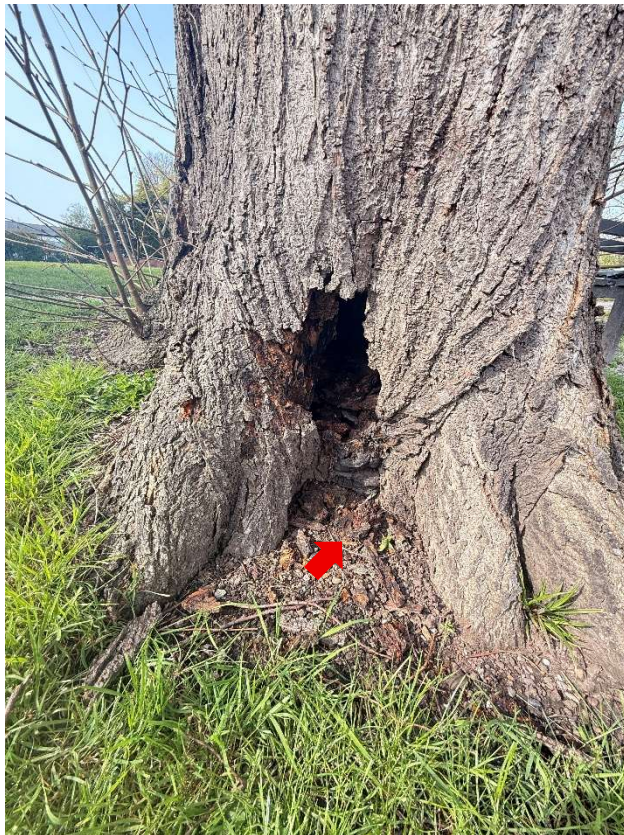
- 2.10 Light basal sucker growth is evident around the base but does not obscure it from detailed assessment. There are multiple cavities between more pronounced root buttresses. These reveal many old, largely senescent fungal fruiting bodies, most likely *Ganoderma adspersum*.

- 2.11 On the southern side of the trunk within the fissure between the two main buttresses, there also appears to be some desiccated old ascomycete fungal fruiting body remains which I suspect are those of brittle cinder fungus (*Kretzschmaria deusta*). Some minor embryonic fungal fruiting bodies are also suspected between one of the buttress fissures on the path side. However, this does not look likely to be the imperfect stage fruiting bodies of the brittle cinder fungus, and it will have to be allowed to develop in order to provide an accurate identification.

Photograph 3: Showing the cavity in lime tree 0824 with the red arrow pointing to old fungal fruiting bodies.

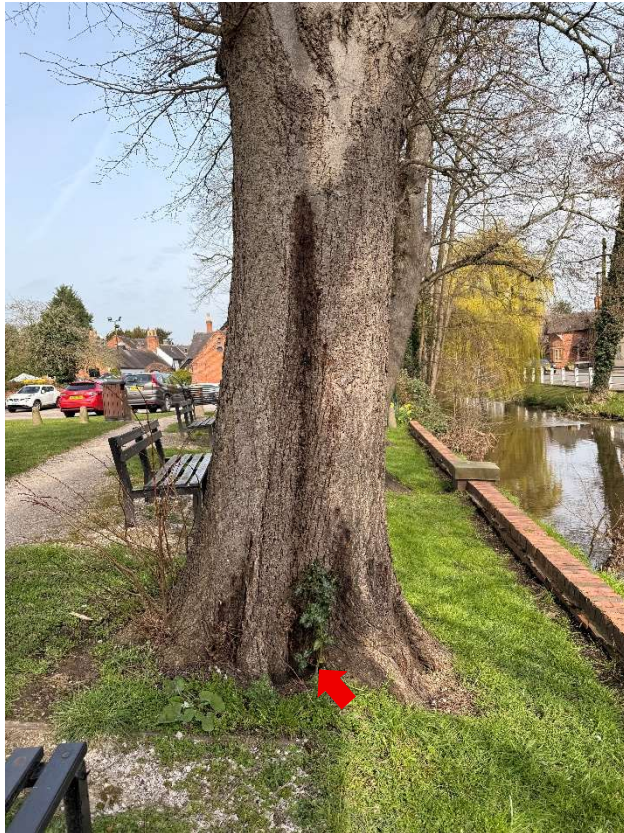
- 2.14 On the northern side of the trunk base, there is a longstanding decayed seam extending around 1.2m to the point of some old *Ganoderma adspersum* fungal fruiting brackets. However, it is clear that a necrotic bark seam extends above this point to around 2.1m, having been partially excavated by tree creepers and woodpeckers; a further clear indication of its dysfunction. Further *Ganoderma adspersum* fungal brackets are evident on the southern side of the trunk base and here there is notable bark bleeding points up to around 2.2m above ground level indicating a *Phytophthora* infection and a degree of bark necrosis.

Photograph 4: Showing lime tree 0825 with bark bleeding evident and a red arrow pointing to old fungal fruiting bodies.

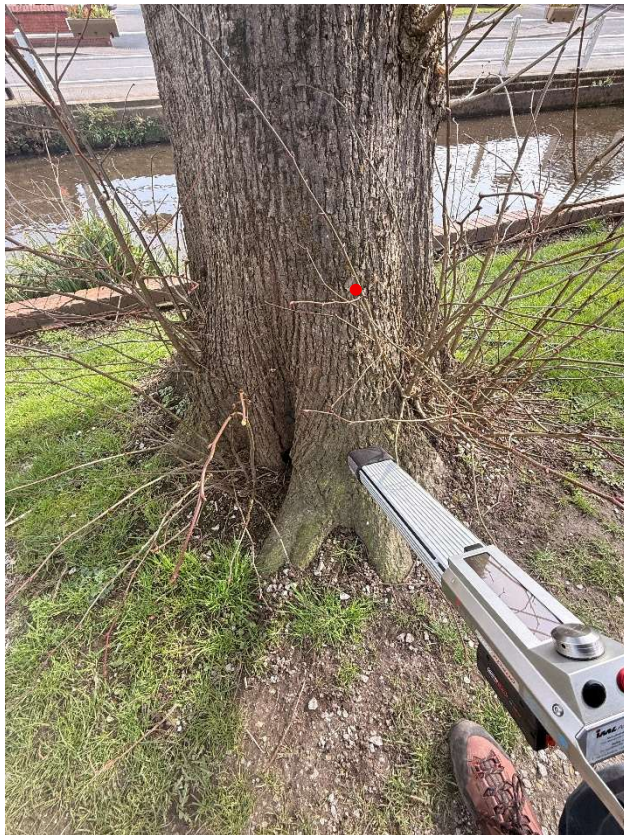
- 2.16 The main opening on the side of the brook was surrounded by heavily decayed material that could easily be removed by hand revealing a substantial basal cavity.
- 2.17 In addition, three test drillings were made. Drilling D1 was made into the main root buttress on the path side. This is considered the primary root buttress providing structural stability to the tree.

Photograph 5: Undertaking test drilling D1 on lime tree 0824 with the red dot indicating the location of test drilling D2.

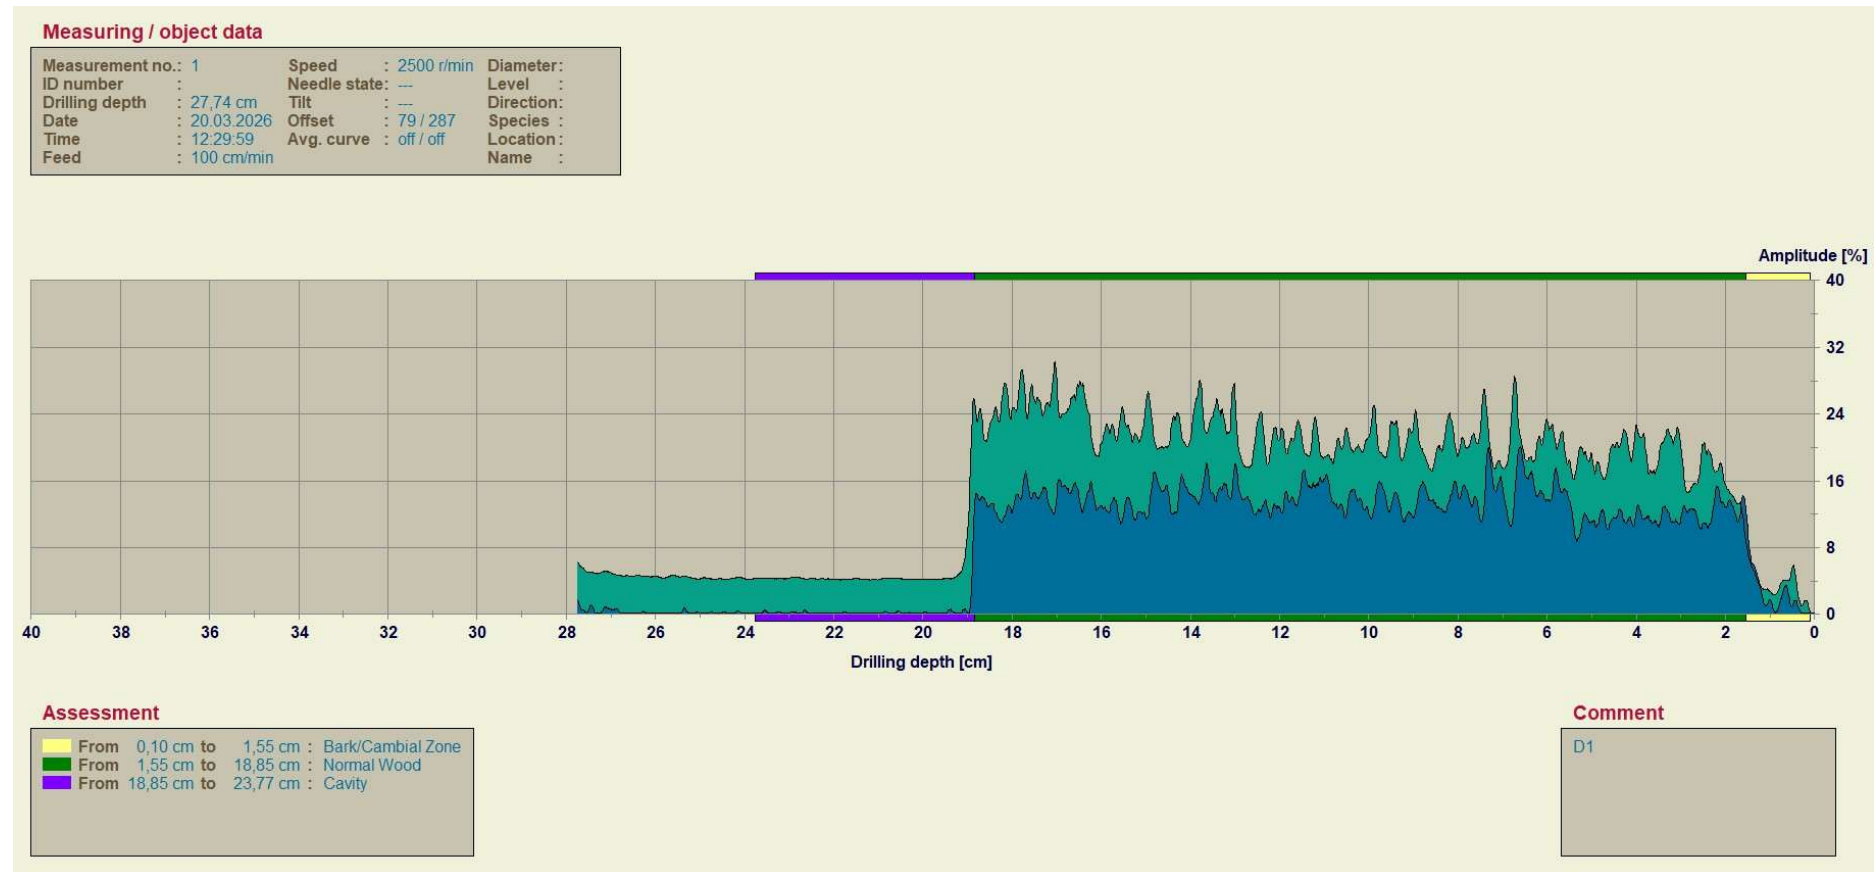
### Test drilling D1

- 2.18 This test drilling was made at around 200mm above ground level and revealed a residual wall thickness of around 19cm (approximately 17–18cm of structural wood) ahead of an entire cavity.

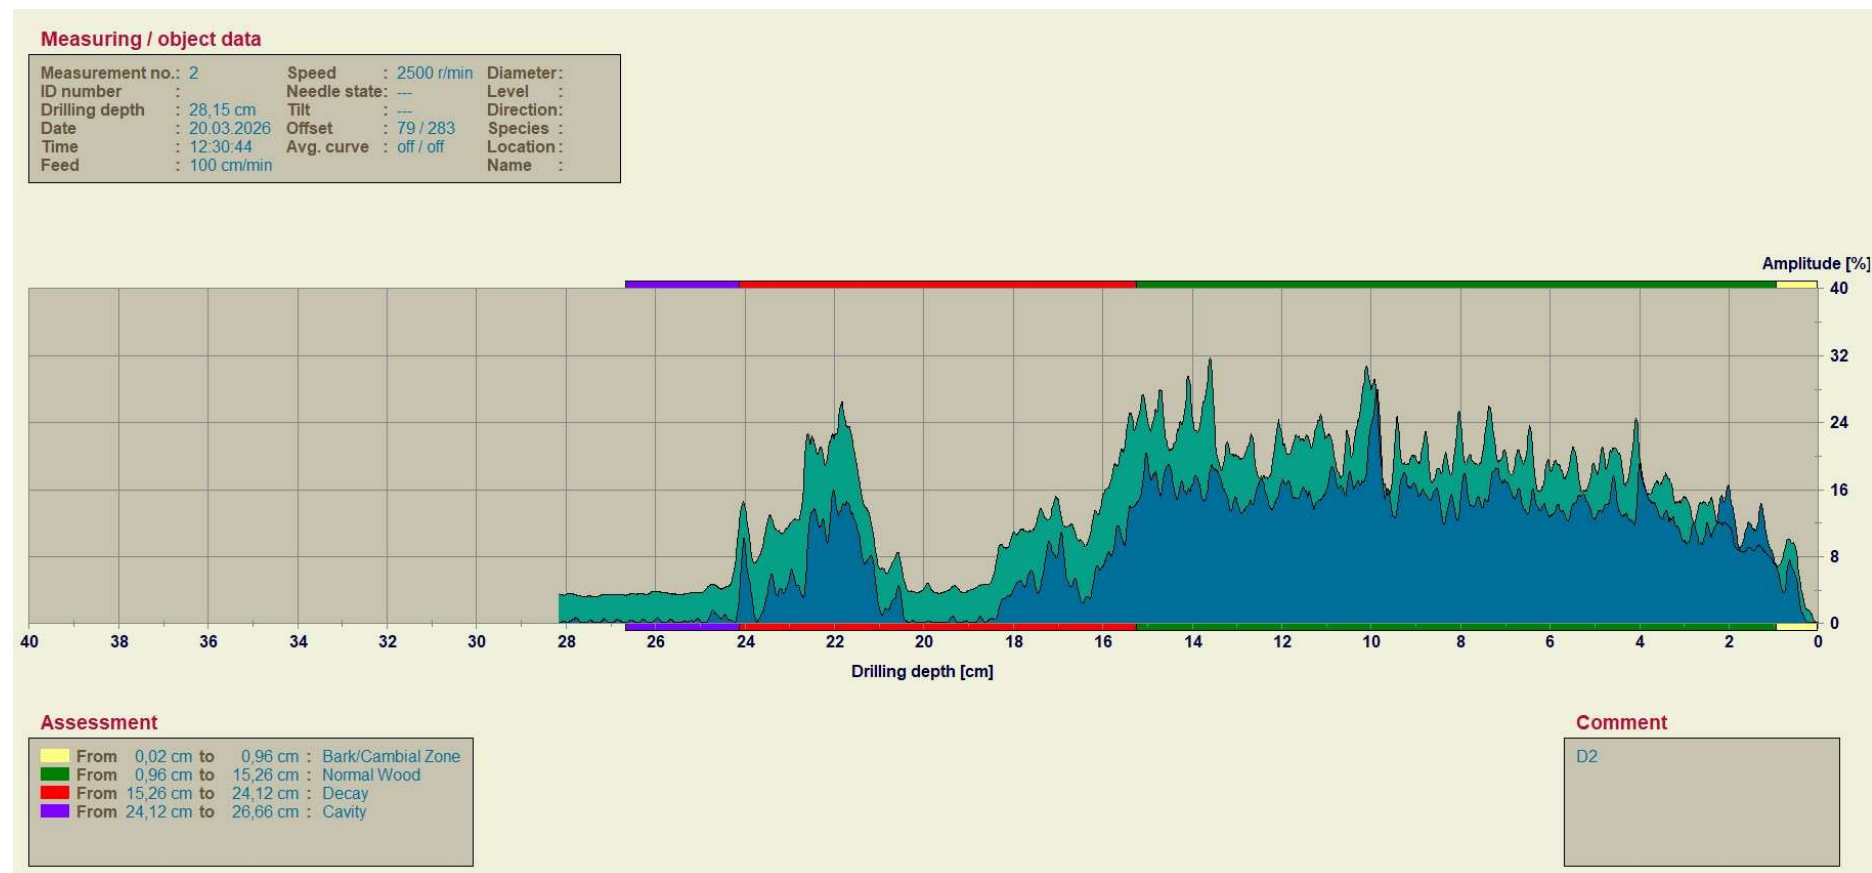
## Test drilling D2

- 2.19 Drilling D2 was made in the same vertical plane as D1 but at around 0.8m above ground level, just above the height of the main swelling where the lower buttress merges into the main trunk. At this point, the outer residual wall thickness was around 14cm and the boundary with the central decayed zone indicated a slow progressive decay with poor compartmentalisation.

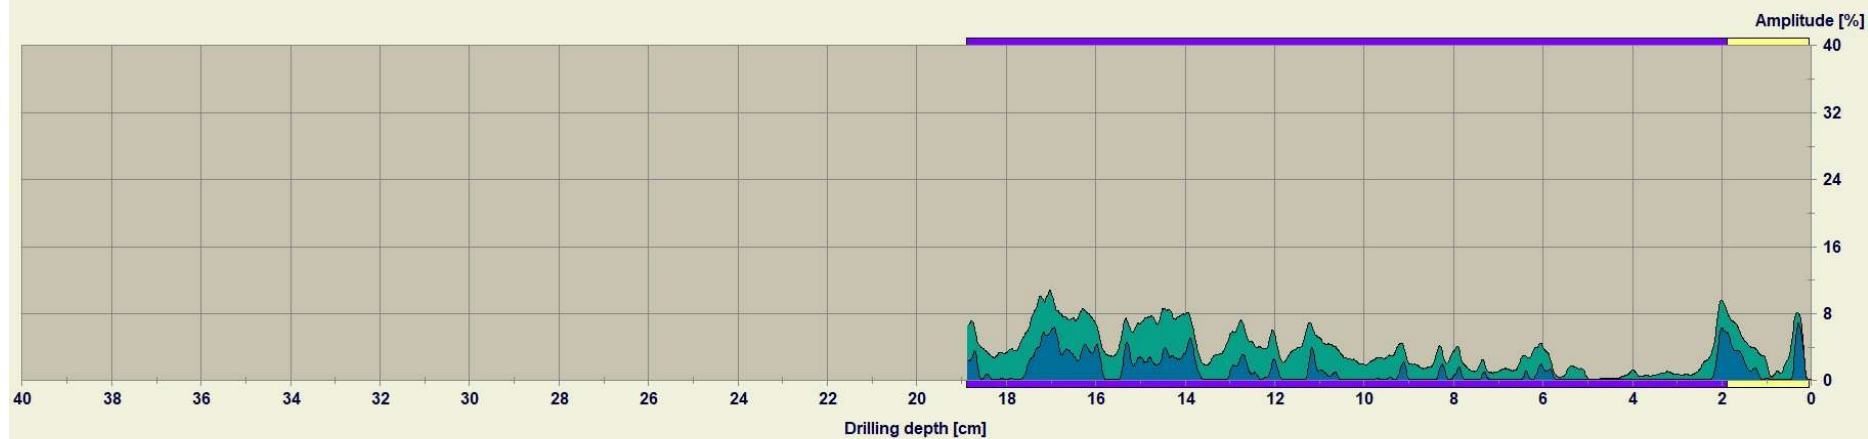
## Test drilling D3

- 2.20 Test drilling D3 was made on the southern side of the trunk into the suspected necrotic bark seam above what is thought to be brittle cinder fungus decay with the test drilling being made at around 0.5m above ground level. This revealed entirely decayed material offering no resistance with the necrotic and decayed area coalescing with the opening on the side of the brook. In total, this equates for around 25–30% of the lower trunk circumference.

| From 0,05 cm to 1,88 cm : | Bark/Cambial Zone |
| From 1,88 cm to 18,90 cm : | Cavity |

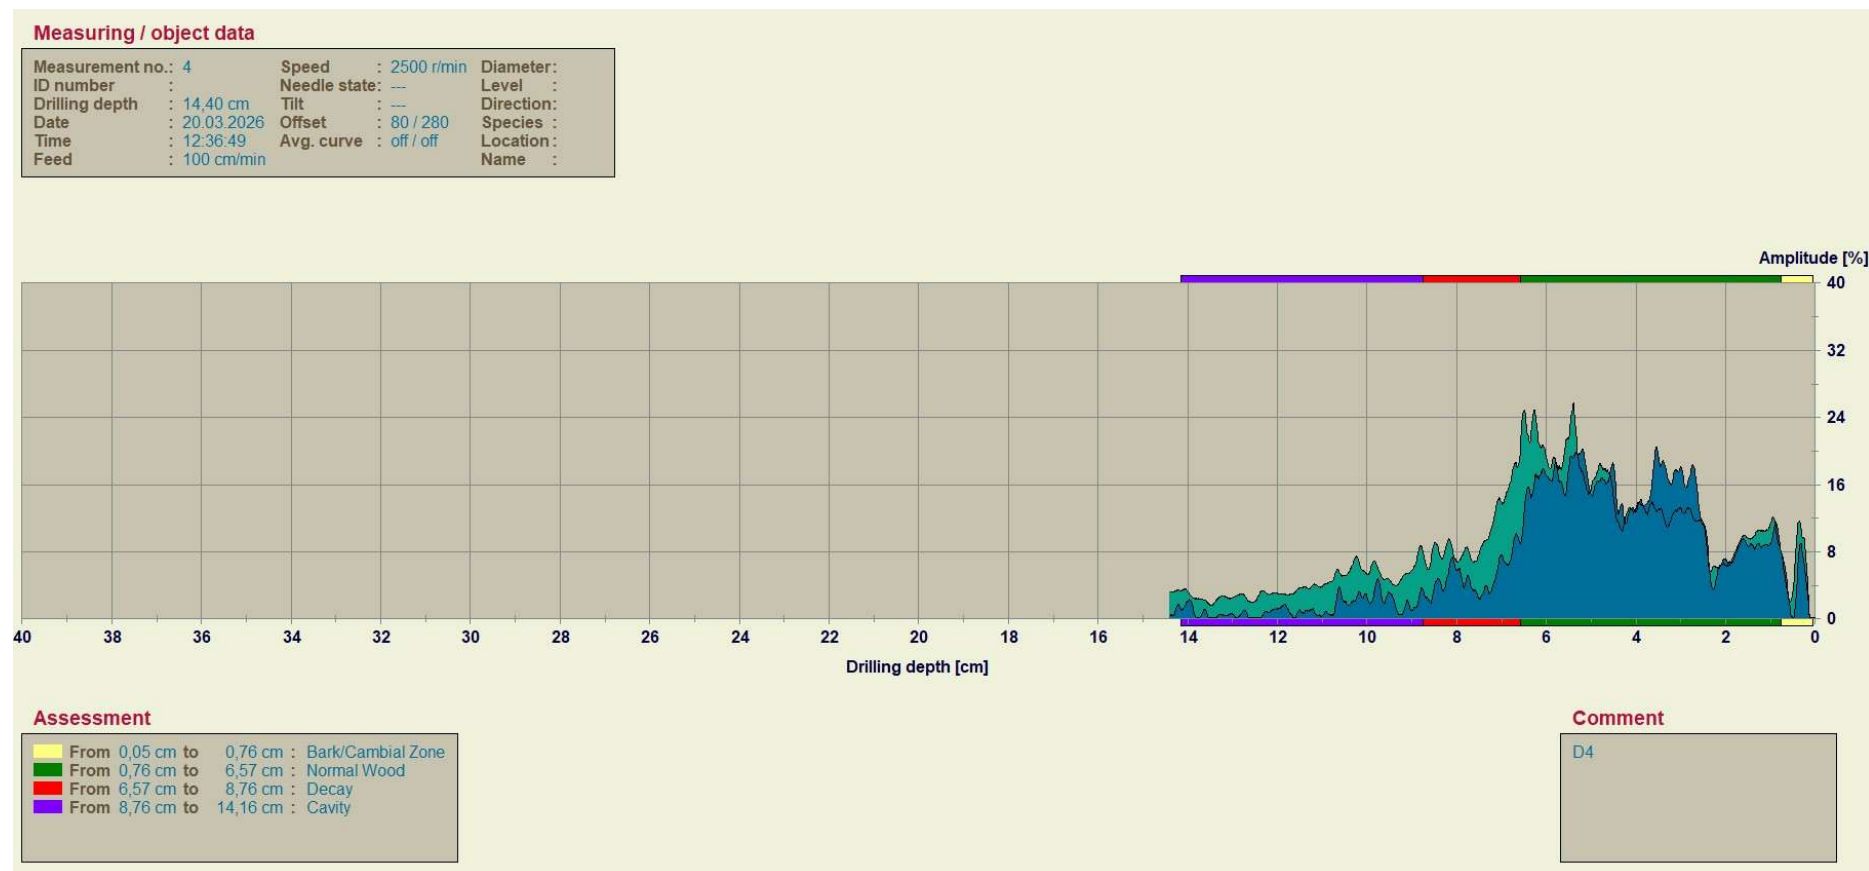
## Test drilling D4

- 2.21 The opening associated with the main fungal brackets is self-evident on the north western stem. At around the height of the upper bracket, test drilling D4 was made into the path side of the stem and revealed a residual wall thickness of only around 6cm. In structural terms, this is very thin. To the northern side of this narrowed, flattened section of stem, there is an abrupt edge to the side of the open cavity. At which point, there is likely to be some ram's horn wound wood formation (obscured externally by bark). However, there is also some indications of possible propagation cracking, which is a primary failure symptom in a hollowed tree trunk.

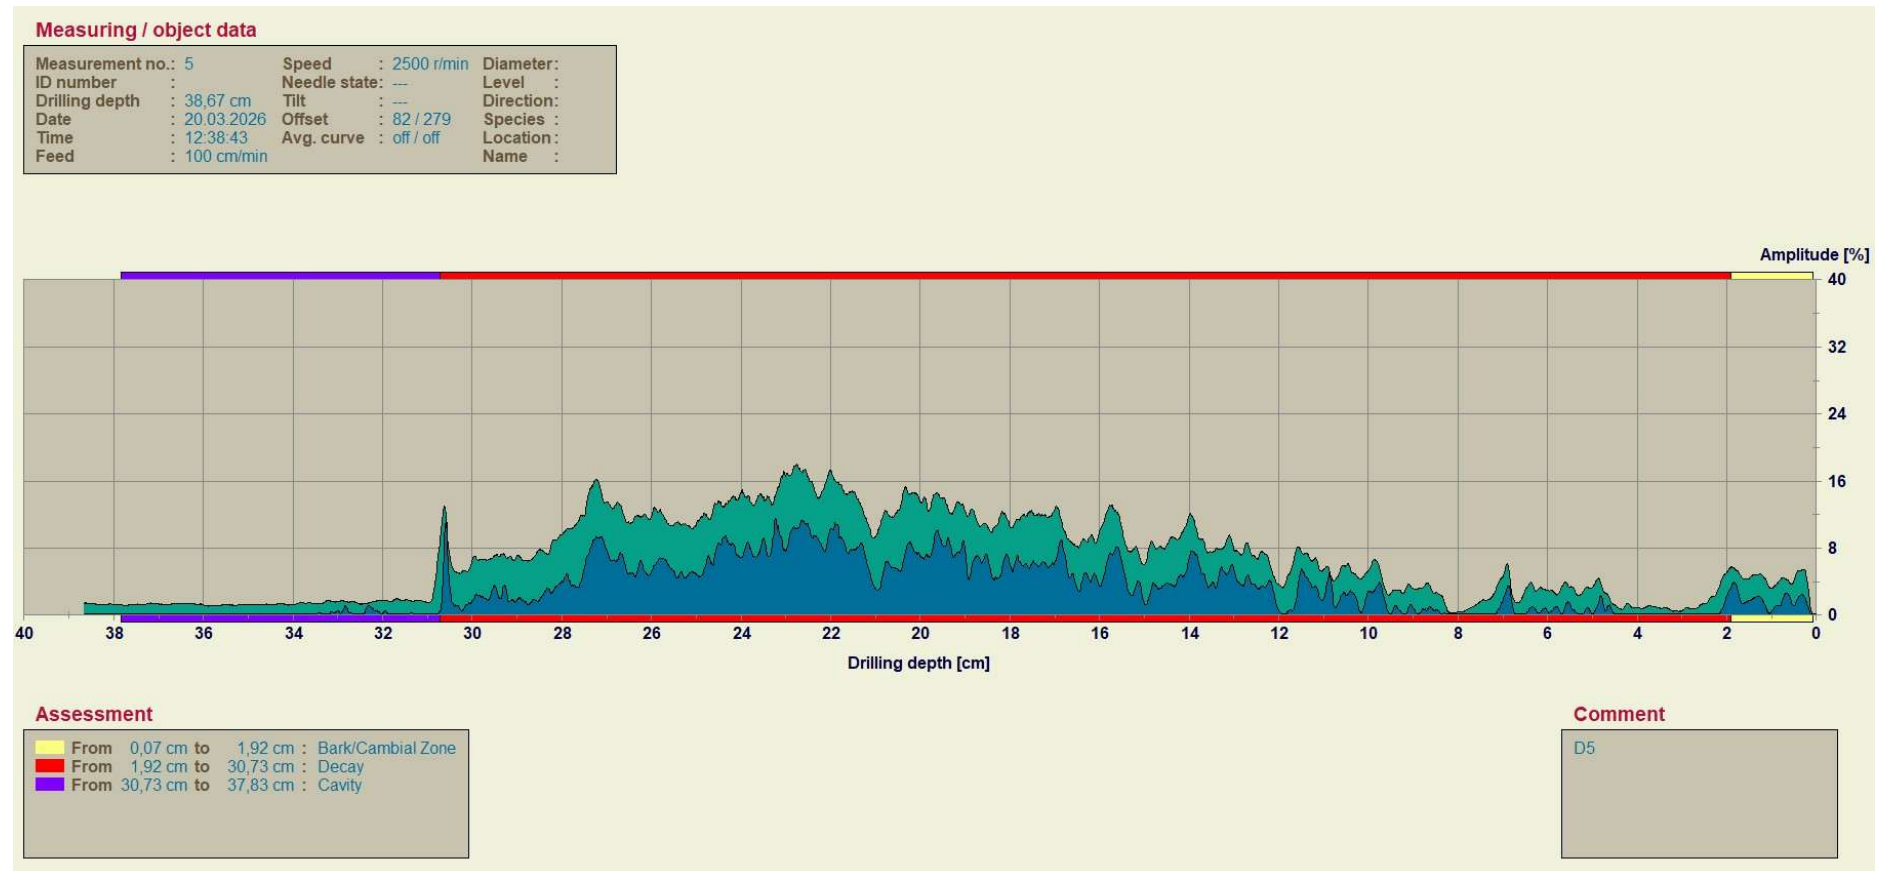
## Test drilling D5

- 2.22 Test drilling D5 was made at around 1m above ground level into the seam with obvious *Phytophthora* staining and above the historic *Ganoderma* brackets. This confirmed that the outer part of the trunk is entirely necrotic with only residual, heavily decayed tissue between 10cm and 30cm penetration, which is offering no structural support.

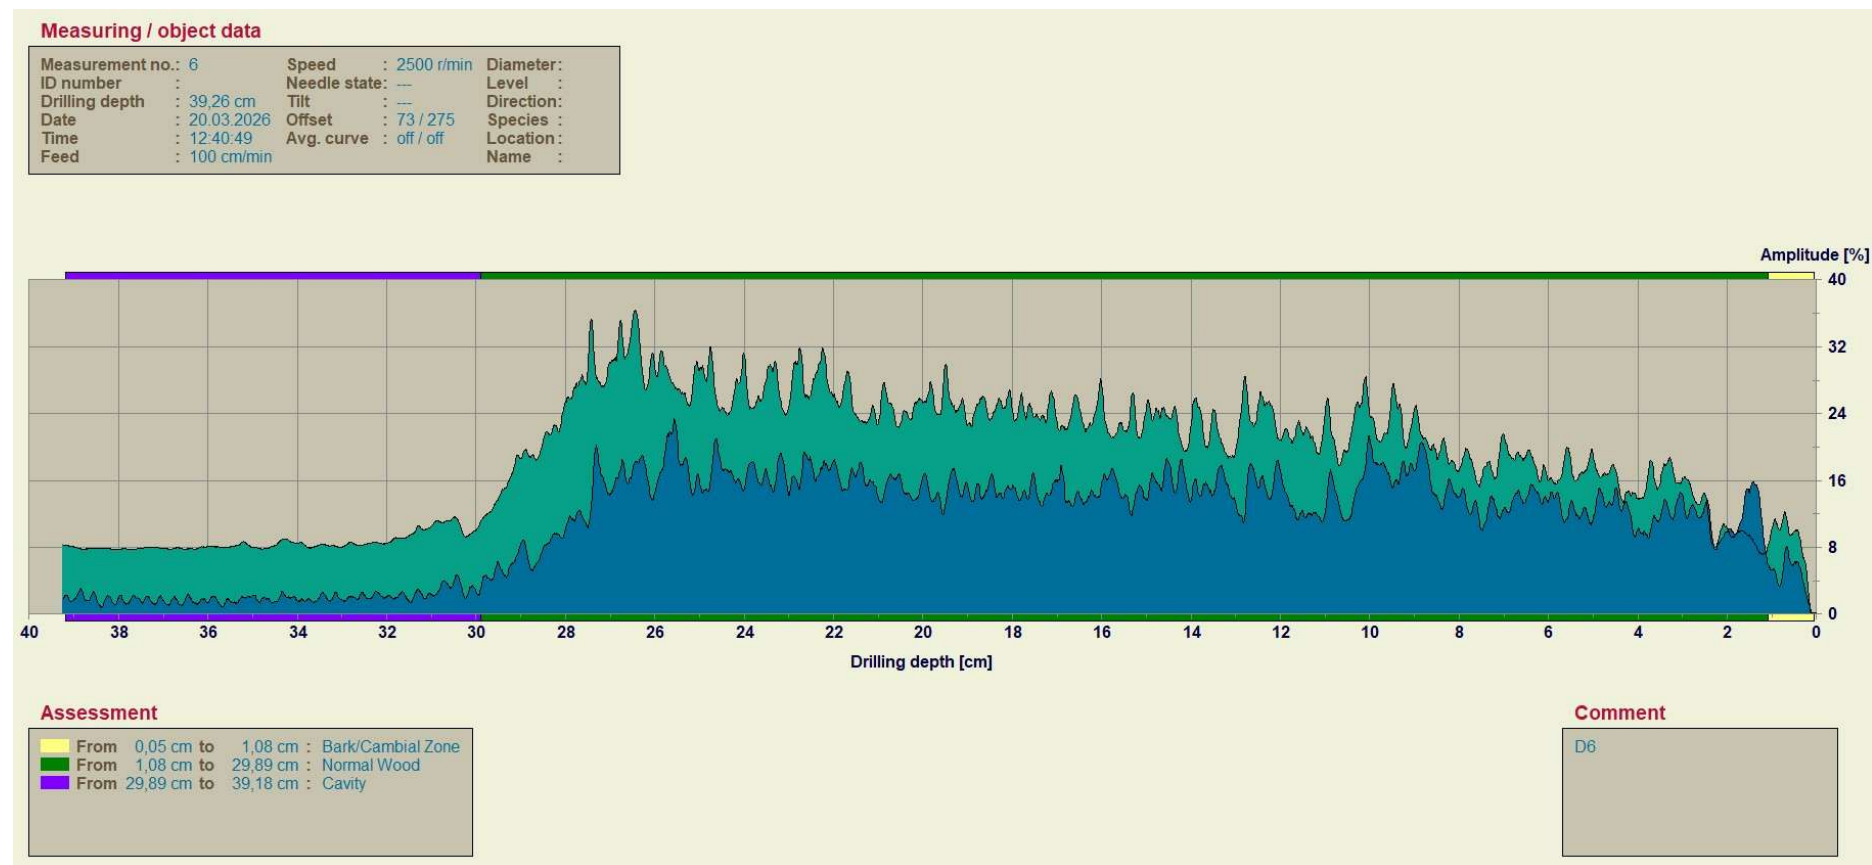
## Test drilling D6

- 2.23 The final test drilling D6 was made into the lower main root buttress on the side of the path. As suspected, this showed better quality structural wood to a depth of around 27cm before a progressive decayed area became an open cavity.
